# Tree location errors in the Chartford Homes Drawings

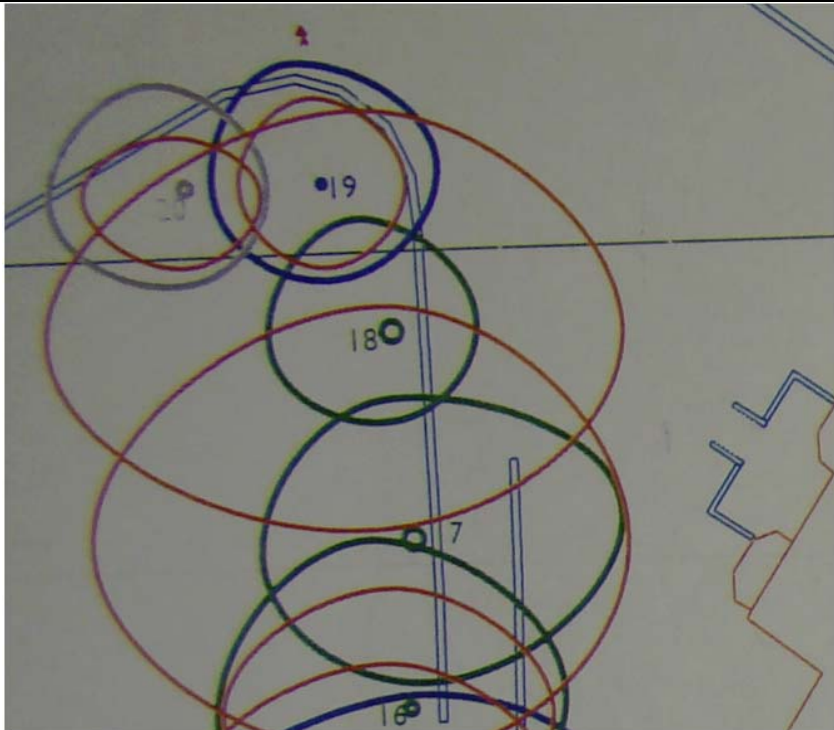
## Tree Survey Drawing

- All trees are shown correctly located.
- Tree canopies shown bold.
- Root spreads shown orange.

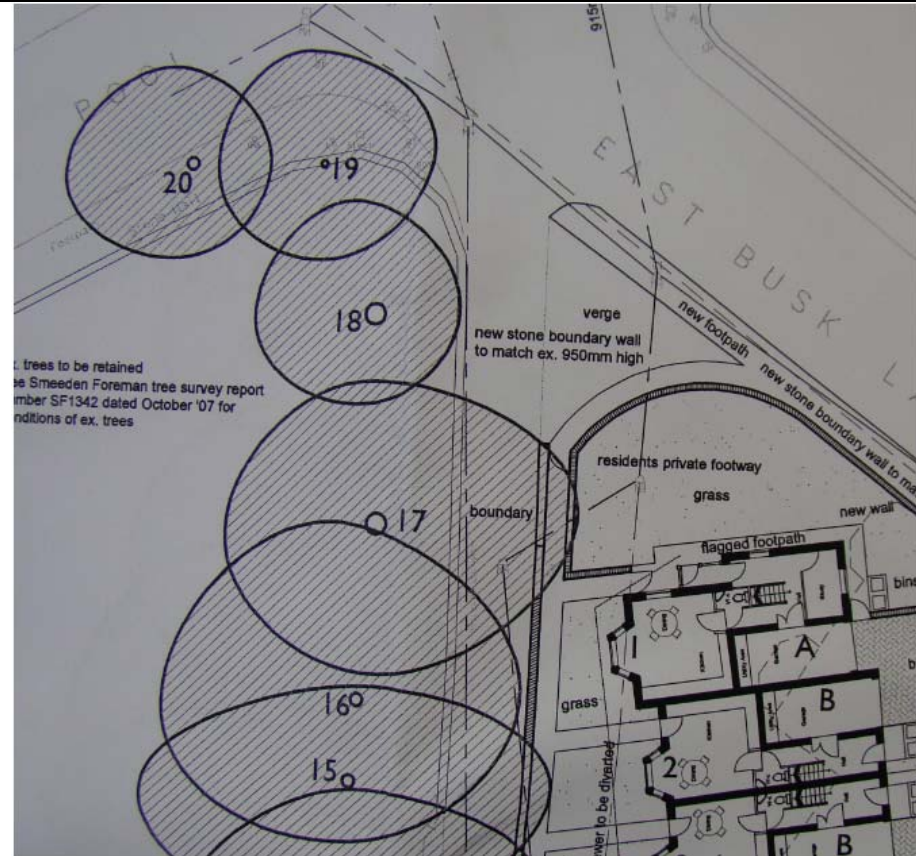
## Development Plan

- Tree 20 is shown in the footpath on Pool Road.
- Park trees miss-placed 5m towards Pool Road.
- Root spreads not shown.
